Manhole Inspection Summary

Manhole # S31M__017MH

Insp Date: **3/16/09 12:47 PM**

Location Address: **CAMDEN YARDS, EUTAW ST,
WAREHOUSE F**

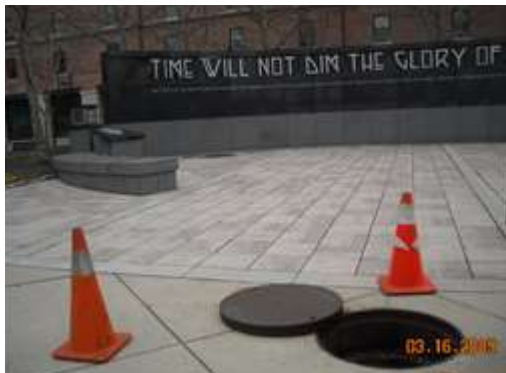
Location View

Comments **NO CHANNEL OR BENCH IN STRUCTURE; LOCATED NEXT TO VETERANS
MEMORIAL; USED 16LB MAUL AND SPRAY LUBRICANT TO FORCE OPEN COVER;
STEAM IN LINE.**

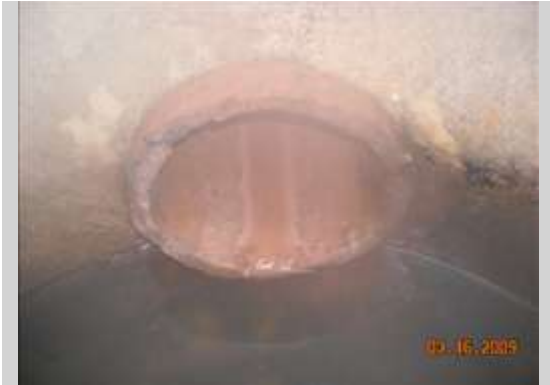
12 O'Clock Outflow

12 in. Circular Gravity Sewer
Pipe Out @ 12 O'Clock

Pipe Material: **Clay** ☐ Pipe Lined

Invert Depth: **9.84** (ft.) Flow Characteristics: **Slow**

Infiltration: **None**

Pipe Seal Cond: **Sound**

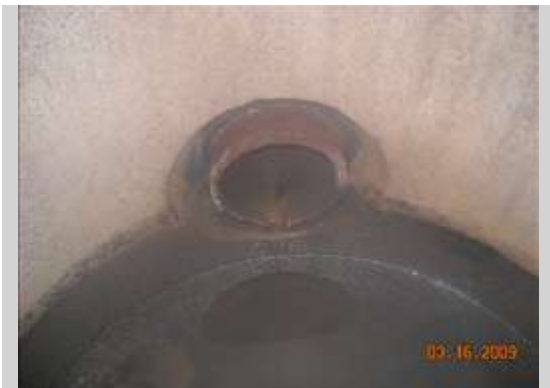
9 O'Clock Inflow

10 in. Circular Gravity Sewer
Pipe In @ 9 O'Clock

Pipe Material: **Clay** ☐ Pipe Lined

Infiltration: **None**
